Planning Advisory Notice

FAA Aviation Obstruction Lighting (“Tower Lighting”)

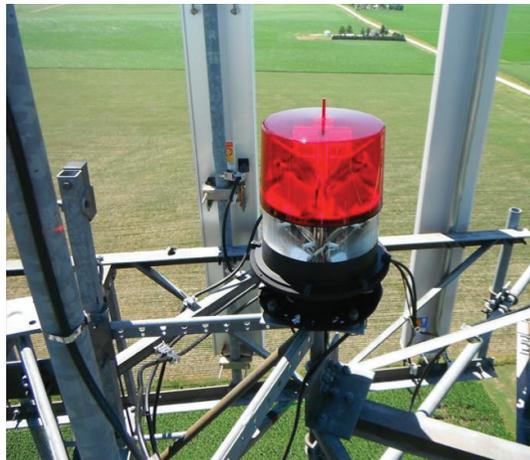
Picture 1: Beacon nested within panel antennas creating an unsafe, obstructed view. Not only is this tower owner subject to a Notice of Violation and forfeiture, the window of liability exposure is wide open if an aircraft incident occurs.

panel antennas, or to add antennas to an existing structure and obstruct the view of the tower lighting. Unobstructed view is iterated throughout the AC 70/7460-1K Chg 2. The top beacon on the tower must not be obstructed or a second beacon must be added (see Picture 1). Lower level beacons and markers must exhibit a 360 degree unobstructed view (see Pictures 2, 3). Failure to follow this procedure creates an unsafe condition.

other appurtenance on the structure and a second beacon may be added at the same level to provide unobstructed view.

supported by a top appurtenance. For example, the beacon can be mounted on a pole (the pole should be designed for this intent and certified to the TIA-222-G addendum II specification) and raised above an array of panel antennas. If raising the beacon would prohibit future inspection and maintenance, the beacon may be lowered to a maximum of 10' below the top of any antenna or

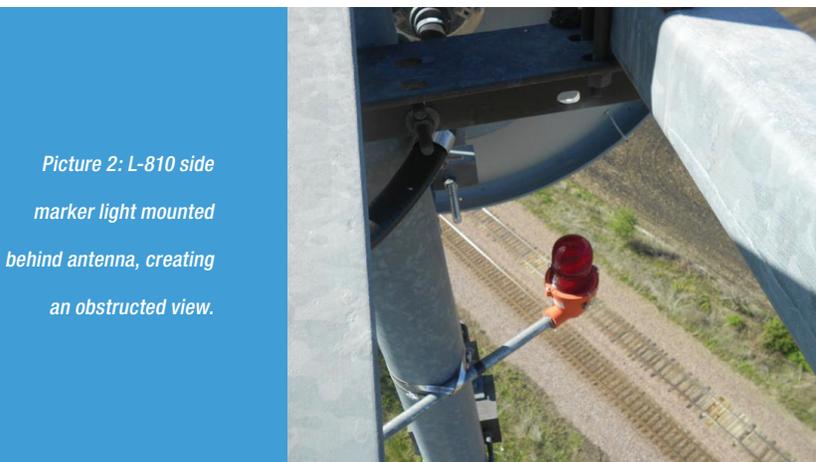
Picture 2: L-810 side marker light mounted behind antenna, creating an obstructed view.

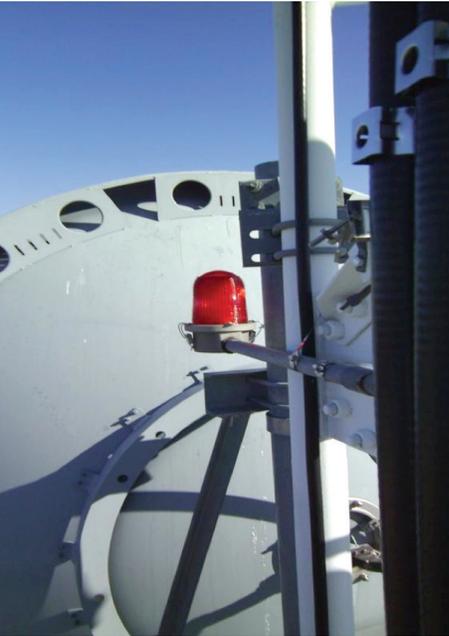
Picture 3: The FCC will allow an adjustment in the placement of an antenna with the proper filing, or the FAA (see AC70/7460-1K Chg 2) allows an adjustment in the placement of the lighting tiers by up to 10'. It is critical to understand that this is a 10' measurement from ground level, not to the base of the tower. Counting tower sections is not a safe means of measurement. All lighting must have an unobstructed view.
