# Roles and Responsibilities

This TIF Planned Advisory Notice or PAN continues to build off the previously published PAN 'A Safe Job Site is No Accident' (2013) and the TIF White Paper 'Appurtenance Installation Impact to Climbing Facilities and Antenna Supporting Structures' (2019). The intent of this PAN is to provide examples encountered in the field and review the impacts and potential dangers they cause in order to improve communication amongst industry Stakeholders, and to develop and plan more effective telecommunications infrastructure installations and maintenance.

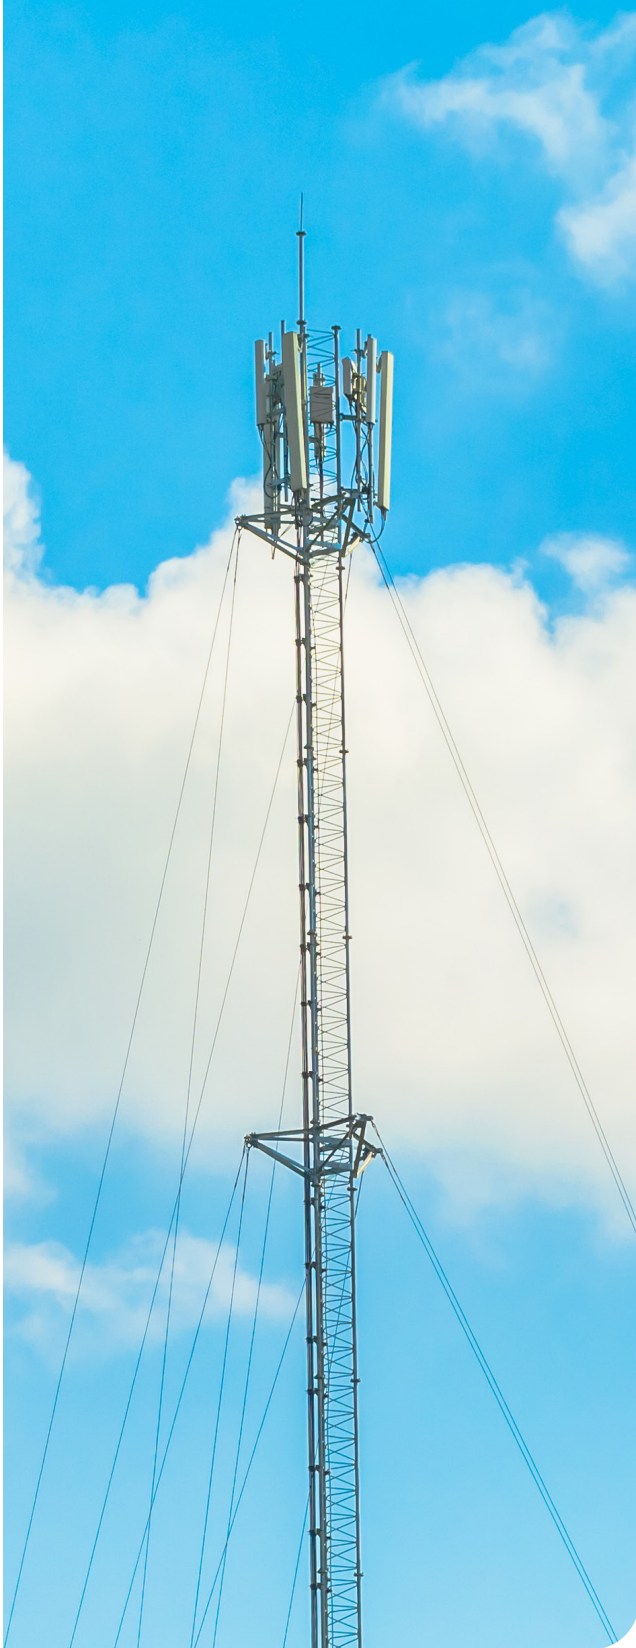
ing. This is a marked improvement since previous drawings in our industry rarely identified any parts or components of the climbing facilities. However, F-1 depicts the new mount being installed towards the top of the tower within 12" of the safety climb head assembly; there is no way to achieve this mount installation without causing damage to the safety climb. The engineer should have considered that they are requesting the mount to be installed in such a manner where the only outcome is damage to the safety climb. In this scenario, there is no path to success for the contractor other than to work with their client to address the issue during the pre-construction planning phase.

Look closely at F-1; it depicts the mount being installed on the safety climb. When the contractor followed the direction of the engineer, it caused damage to the safety climb. It must be noted that climbing facilities can, and sometimes must, be obstructed. But as is seen in the 'Appurtenance Installation Impact to Climbing Facilities and Antenna Supporting Structures' TIF White Paper, such obstruction shall never cause damage. Now reference P-1 and you will see how problems can multiply when there is not proper planning and communication.

The mount was installed as shown on the drawing and the safety climb is now damaged. THINK for a moment - please just pause, does it make any sense to damage the safety climb that is intended to protect people? This safety climb was intended to help tower climbers access this site and increase tower climber productivity while maintaining our industry's 100% tie-off at all times requirement. Remember that all work must be planned to ensure a safe working environment and the use of the safety climb as part of a fall protection plan shall only occur under the supervision of a competent person. It will take all of us acting from our given roles and levels of responsibility working together, but we must stop damaging the climbing facilities and safety climbs on structures.

To recap, what happened; the drawings were incorrect and the engineer should have applied the knowledge that they had of the location of the climbing facilities and safety climb in planning the mount layout to ensure that the safety climb would not be damaged. Some simple solutions that may have been used would have included rotating the mount or installing a mount that would allow the safety climb to pass through the mount (see below Picture 2 [P-2]).

In this scenario presented in P-1 and F-1, the contractor arrived on the site before the issue with the drawings was noticed and they did not escalate the situation seeking an effective solution, so the mount was installed as designed and damage has now

occurred to the safety climb. In this case we have a failure attributed to the engineer from a design standpoint and a contractor installation failure. The failure occurred because the design did not allow for a quality install and instead of escalating the issue for resolution, the contractor installed as-designed causing damage.

Rather than blindly installing what is depicted on a drawing, a more effective approach is to have a path that allows the contractor's competent person on site to be able to stop work if it is going to cause damage to the structure, climbing facilities, safety climb (if present), or any other known system installed upon the structure. What would that look like? How do we as an industry achieve this? Let's first look at it for a moment and understand the schedule and cost impact from the perspective of the contractor. The women and men installing the telecommunications infrastructure often are not subject matter experts on available products or even understand that there is an escalation path in order to not cause harm. They are often only following the information that was passed down to them; and if the information is unclear, the installation may not have the best outcome. A contractor's goal is to finish the project safely, meet client expectations, and make a profit so it can stay in business, pay their employees, and be in a position to support its' clients' next project. The contractor is engaged to perform the SOW, not to field-engineer a solution, however, a quality contractor can effectively relay information when an issue is identified so that the stakeholders involved in the project can come together to support a quality installation in a safe and efficient manner.
