Planning Advisory Notice

Anchor Bolts: Height Matters

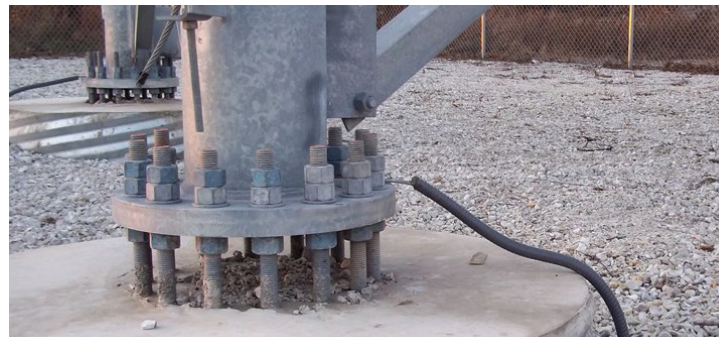
This anchor bolt installation shows an example of dangerous stress caused by too much height.

Resolving the problem can be difficult. Lowering the tower is expensive, can damage the anchor bolts and if not done properly may lead to binding of the tower on the bolts. Adding high strength non-shrink grout is an acceptable solution if approved by a competent engineer in accordance with TIA-222-G requirements. More recently, there has been a movement to eliminate grout from installations to reduce maintenance costs. Poor grout installation and improper grout material contribute to the movement to eliminate grout. Inspection of anchor bolts once grouted is not feasible without the complete removal and replacement of the grout. In some installations, grout has contributed to localized corrosion of the anchor bolts which often goes undetected. Replacing grout with shims made of steel or other acceptable materials has also been contemplated. Using shims

allows inspection of the anchor bolts and serves as an acceptable substitute to grout. The use of shims must be reviewed by a competent engineer prior to the installation. In any event when stacking a tower the installer should confirm the placement of the leveling nut is compliant with the manufacturer specifications and the bottom of the nut should not extend more than one bolt diameter above the concrete. ■

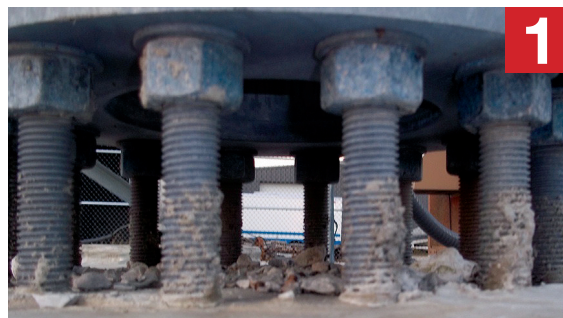
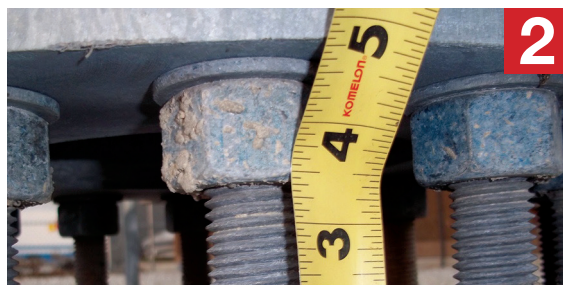
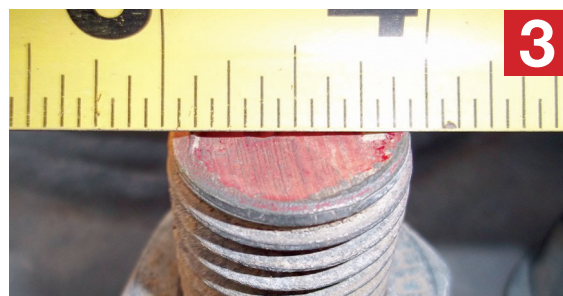
It has become all too common during structural maintenance and inspections to discover anchor bolts extending far above the top of the foundation. TIA design standards place limits on the height to maximize the bolt capacity. If not grouted, the height of the bottom of the anchor bolt above the concrete should not exceed one bolt diameter. It is important to note that some tower manufacturers require the use of grout and the grout should be placed in accordance with these recommendations while the height of the grout should not extend beyond the limitation set by the engineer of record.

When the height limitation is exceeded the bolts are subject to bending forces and these bending forces must be evaluated in accordance with the TIA standard by a competent engineer. The bolts will have a tendency to move horizontally when

subjected to the horizontal wind forces from the tower. These forces grow quickly overwhelming the anchor bolt strength. If this condition is encountered, it is important to convey the situation to the design engineer for review. Collecting the height of the bottom of the nut above concrete is a simple act.

For example, as the photos to the right illustrate, the bolt in this installation is a 1" diameter (Photo 3). The height of the bottom of the nut is 3.5" (Photo 2), which is 3.5 times the 1" height limitation. This extension of the anchor bolts can result in stresses that greatly exceed the TIA stipulated strength.
