TELECOMMUNICATIONS
INDUSTRY FOUNDATION

Building-Mounted Structures in the Telecommunications Industry

Publication Date October 2024

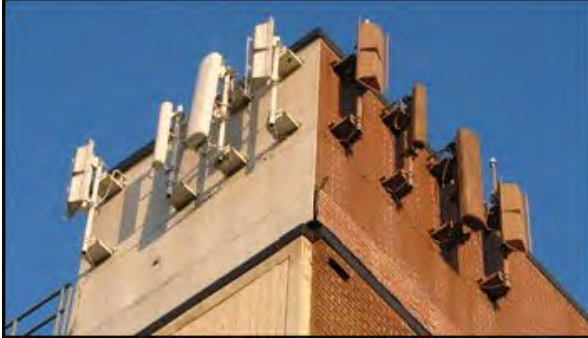
Figure A.a.1: Wall mount installed on outside of building

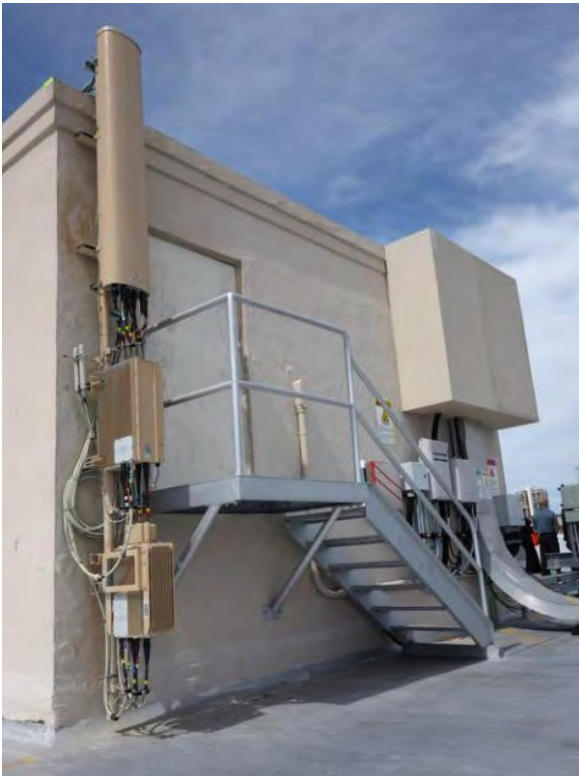
Figure A.a.2: Wall mount installed on the penthouse wall of a building

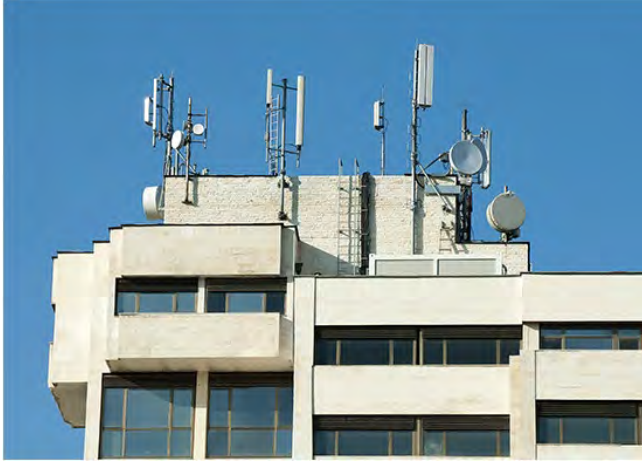
Figure A.a.3: Different types of wall mounts installed on the penthouse wall of a building

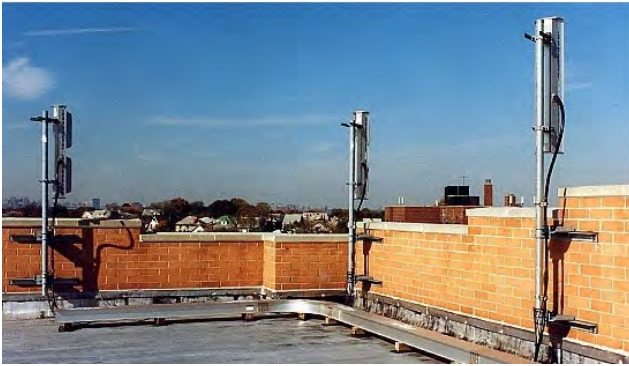
Figure A.a.4: Pipe wall mount installed on parapet wall of a building

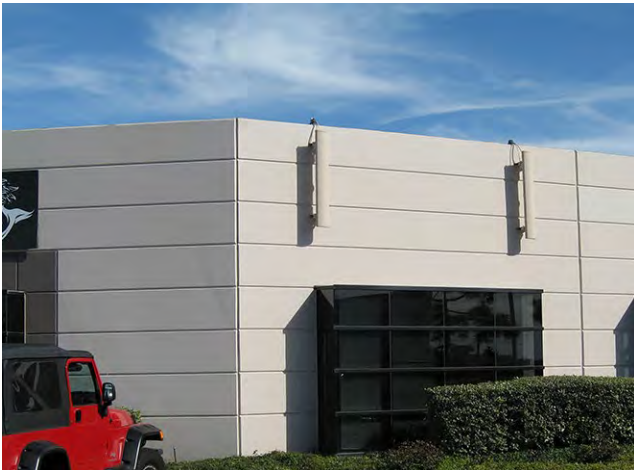
Figure A.a.5: Pipe wall mount installed on the wall of a building

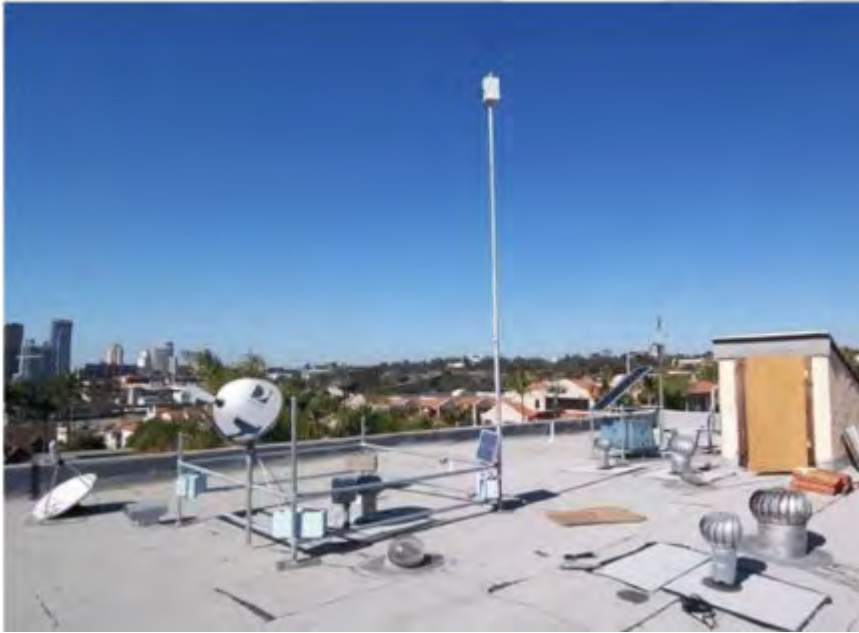
Figure A.b.1: Custom penetrating mount supporting radio and dish equipment

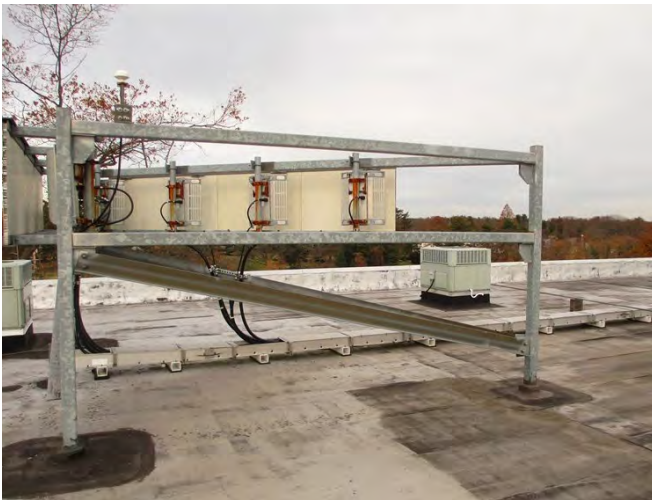
Figure A.b.2: Custom penetrating triangular frame

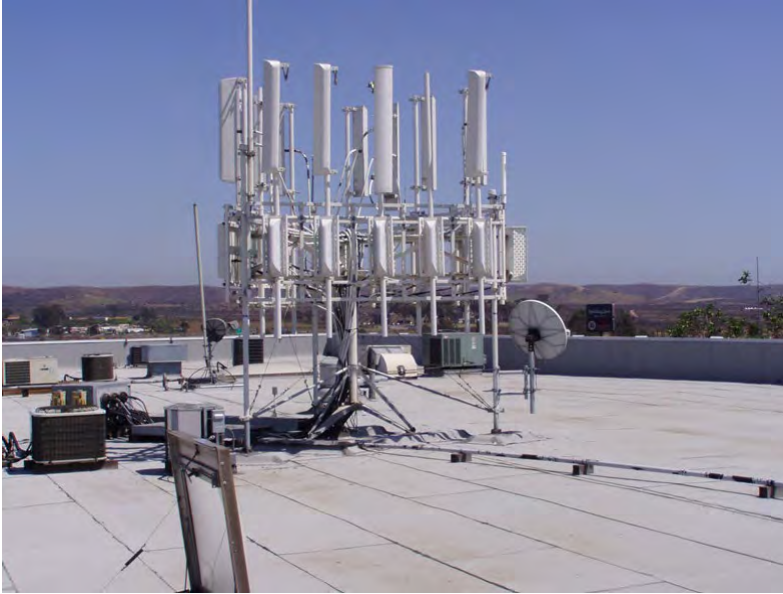
Figure A.b.3: Custom penetrating triangular frame with tripod mount

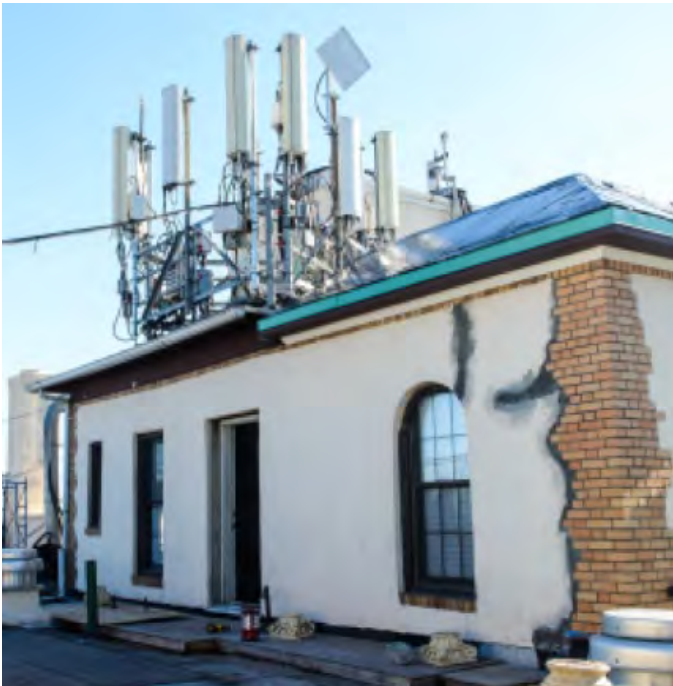
Figure A.b.4: Custom penetrating rooftop mount installed on penthouse roof

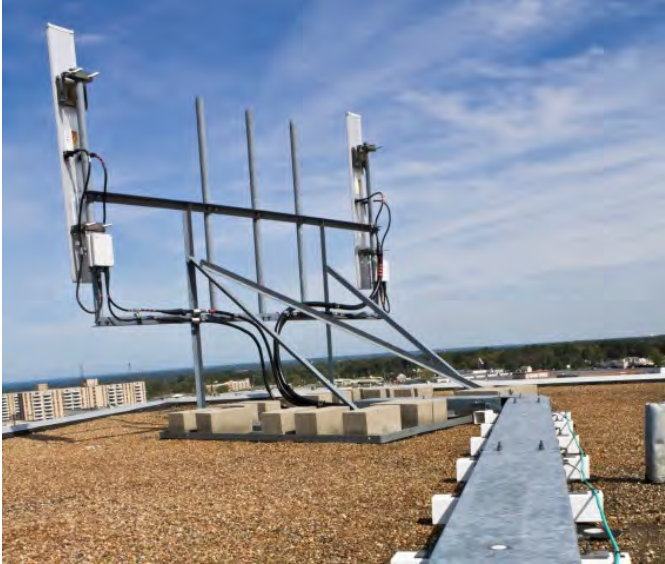
Figure A.b.5: Non-Penetrating ballasted sled mount

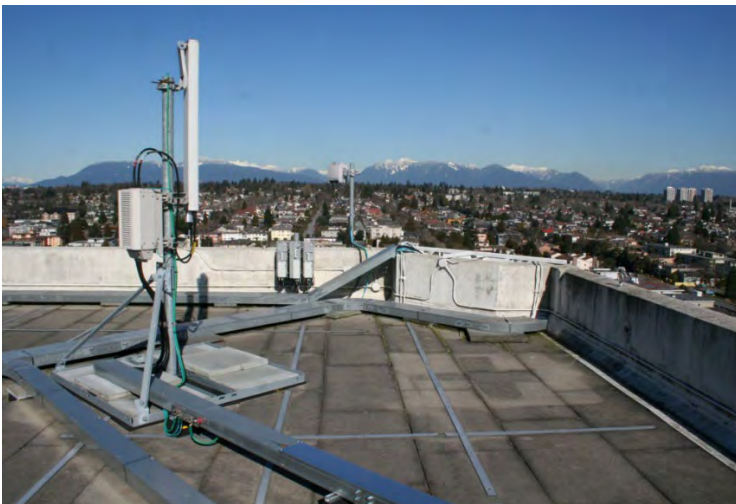
Figure A.b.6: Non-Penetrating ballasted tripod mount

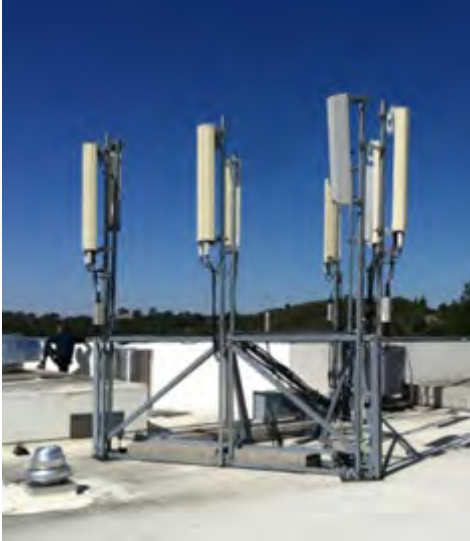
FigureA.b.7: Non-Penetrating ballasted triangular mount

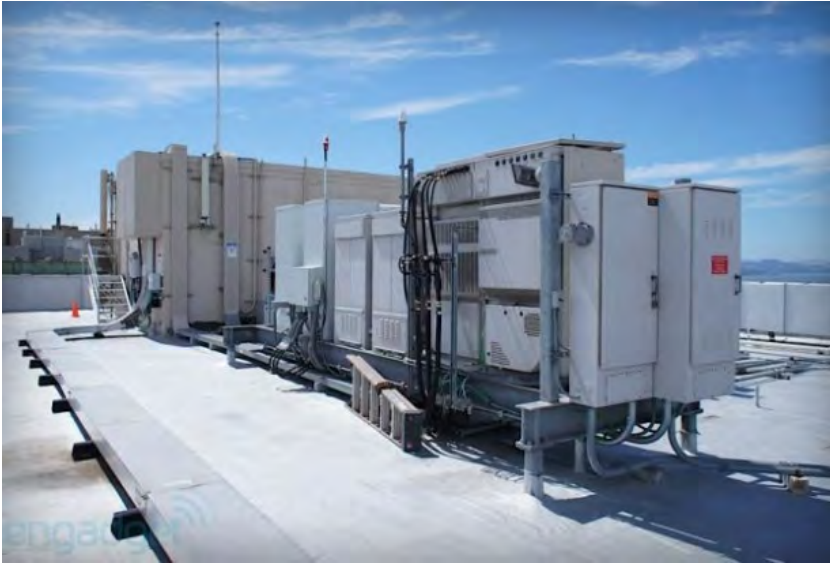
Figure A.c.1: Custom equipment platform

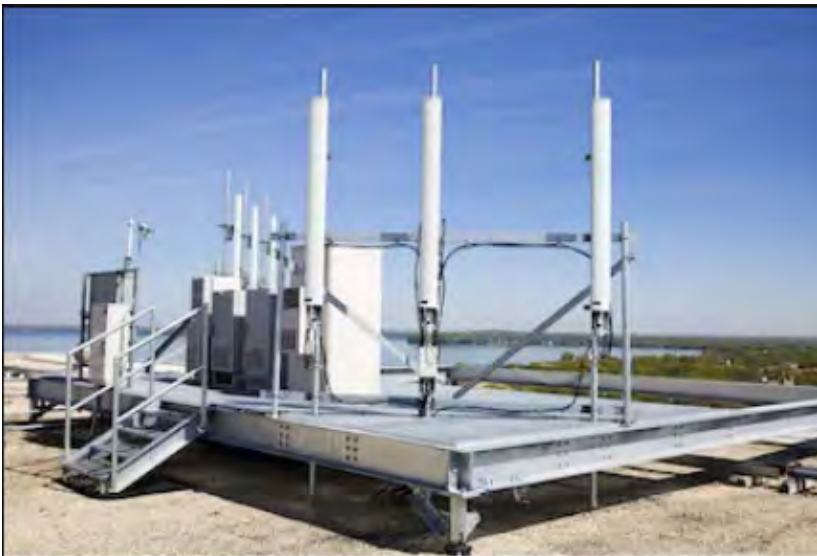
Figure A.c.2: Penetrating mount installed on equipment platform

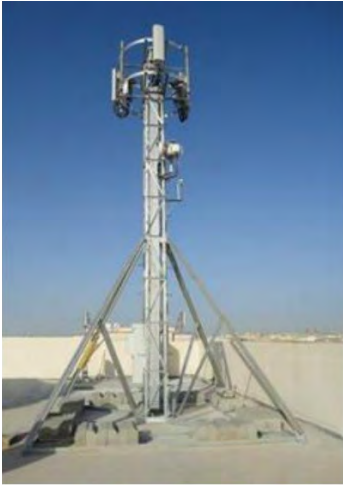
Figure A.d.1: Small Lattice Tower ballasted on corner of a building roof

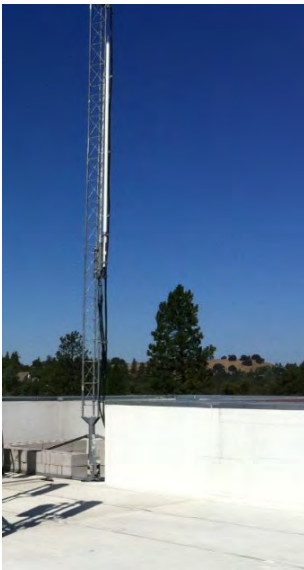
Figure A.d.2: Small Lattice Tower ballasted on corner of a building roof

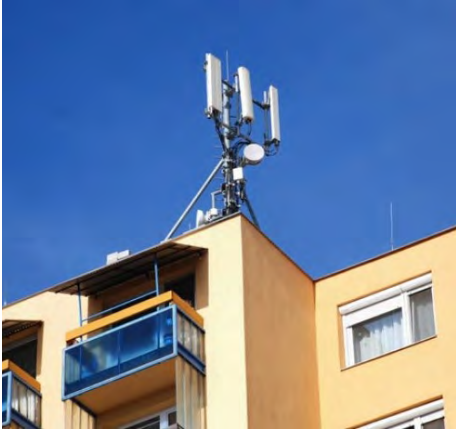
Figure A.d.3: Small Monopole Tower installed on a building roof

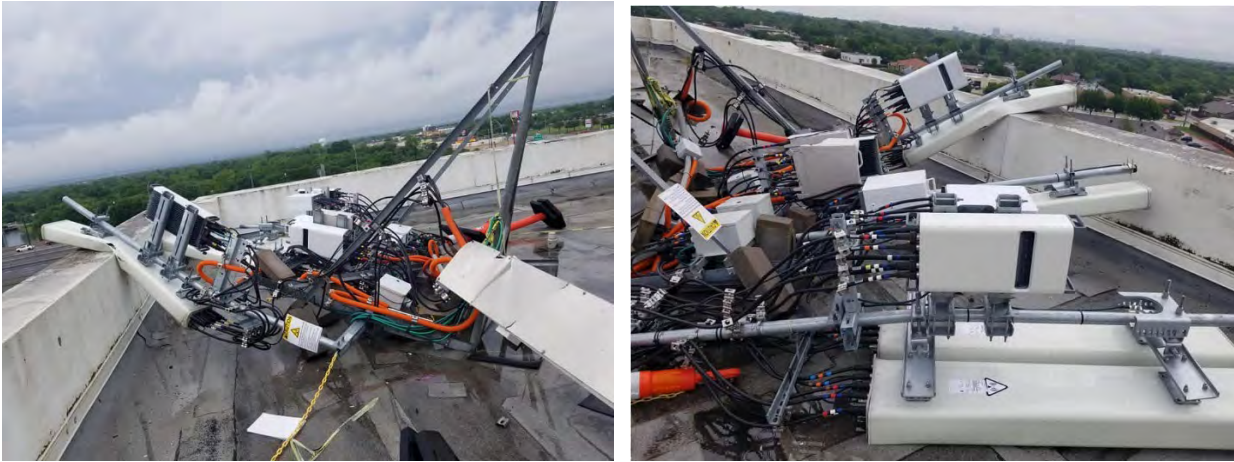
Figure B.1: Rooftop sled-mount frame overturned as a result of not having enough CMU blocks

Figure 1 and 2 in Appendix B are examples of non-penetrating mounts which failed due to overturning because they were installed using improper ballast quantities. The images show little to no ballast blocks present. Figure 3 is an example of ballast blocks improperly installed to the mount. Figure 4 reflects failure due to improper installation as the main vertical member was not fully seated in the sleeve and then secured.

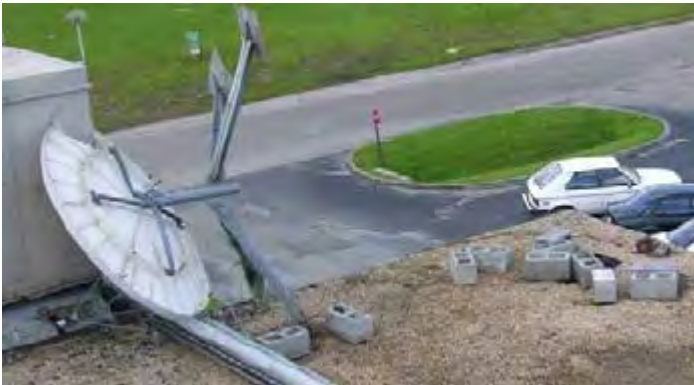
Figure B.2: Rooftop satellite Dish overturned as a result of not having enough CMU blocks and blocks not properly placed.
(Ref: [FEMA 543](#))

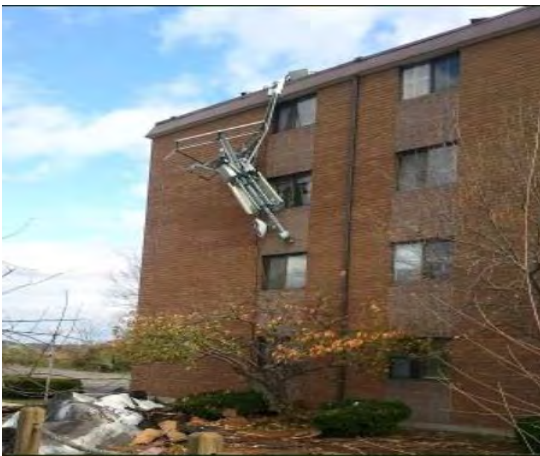
Figure B.3: Rooftop tripod mount fell off the roof as a result of not having enough CMU blocks or proper anchorage

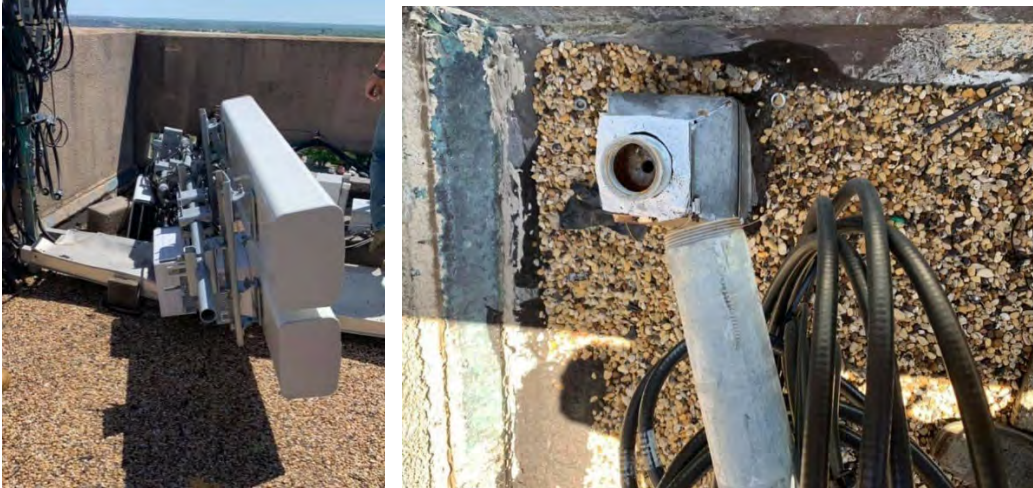
Figure B.4: Parapet Panel antenna mount failure due to improper anchorage

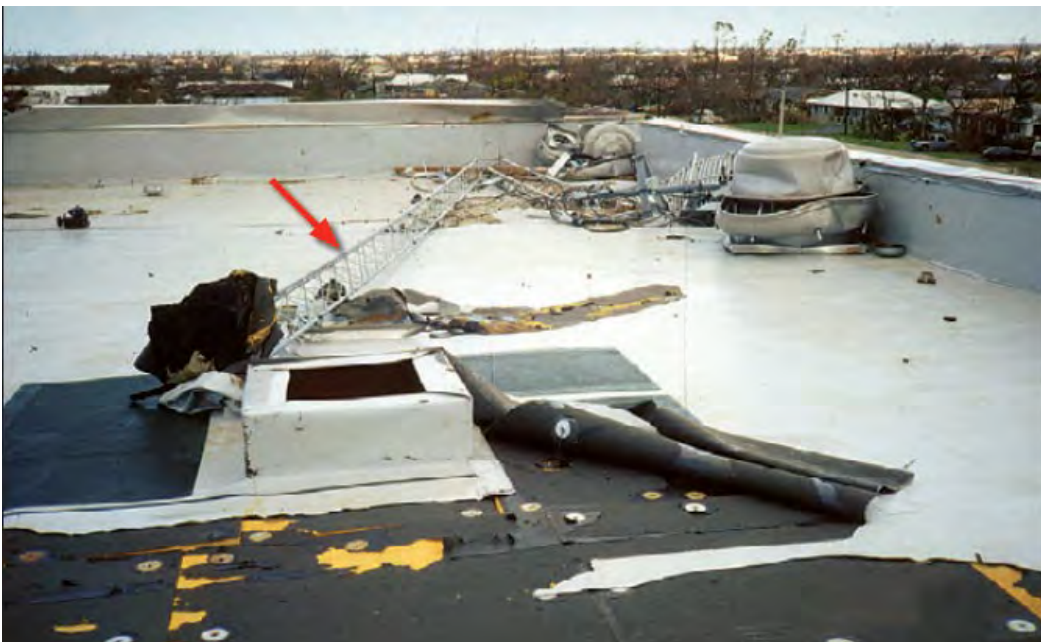
Figure B.5: Collapse of roof mounted antenna tower including progressive peeling of the roof membrane (Ref: [FEMA 543](#))

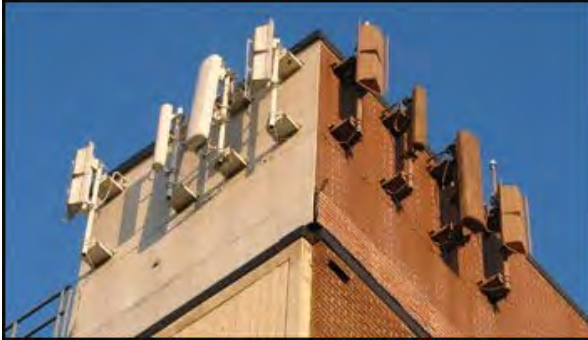
Figure A.a.1: Wall mount installed on outside of building

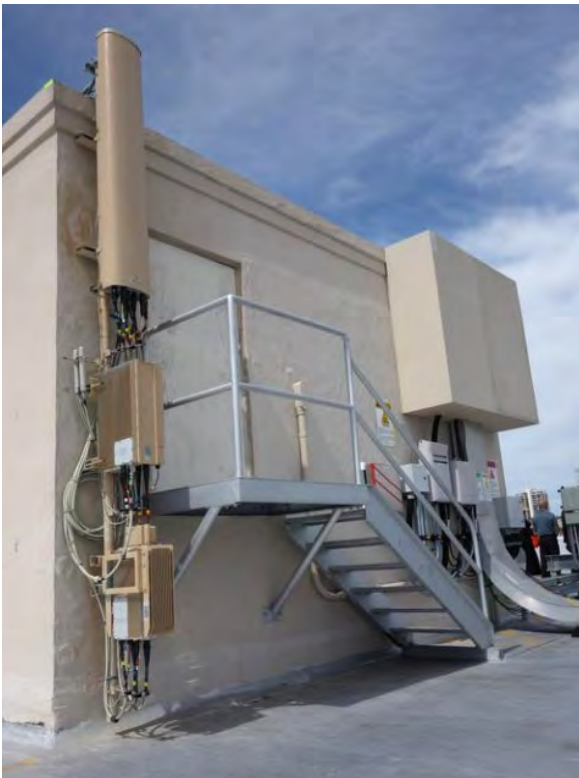
Figure A.a.2: Wall mount installed on the penthouse wall of a building

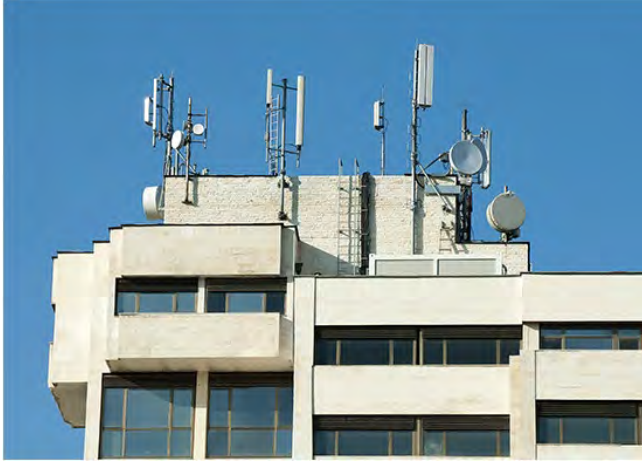
Figure A.a.3: Different types of wall mounts installed on the penthouse wall of a building

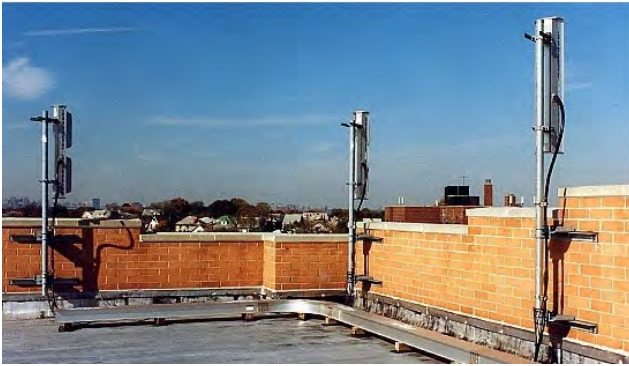
Figure A.a.4: Pipe wall mount installed on parapet wall of a building

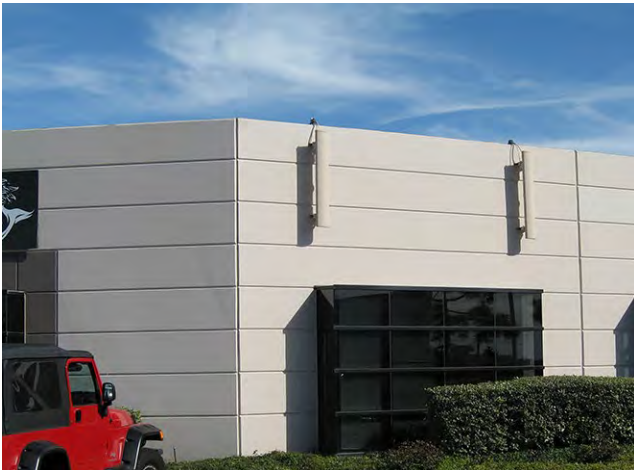
Figure A.a.5: Pipe wall mount installed on the wall of a building

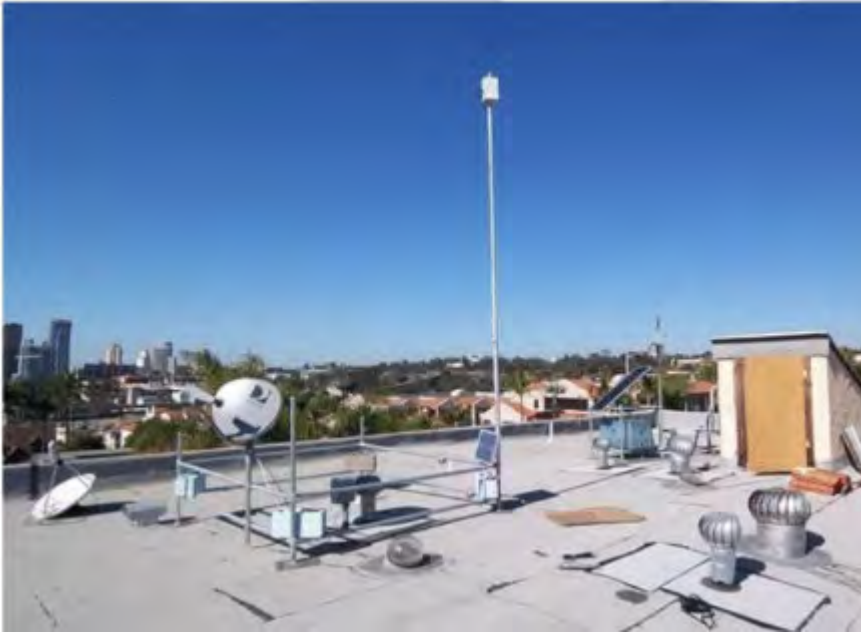
Figure A.b.1: Custom penetrating mount supporting radio and dish equipment

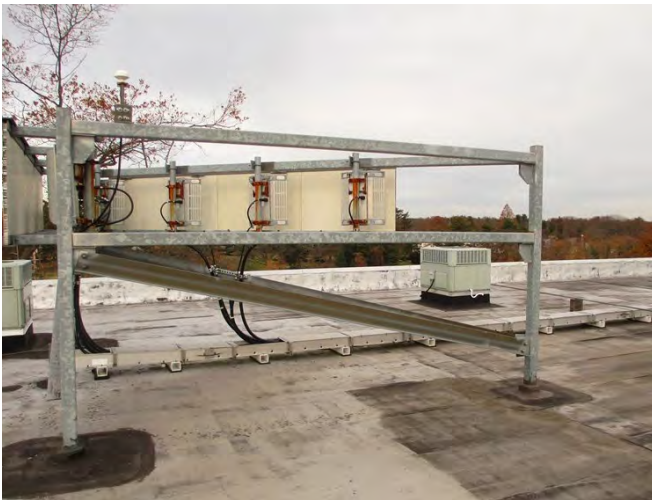
Figure A.b.2: Custom penetrating triangular frame

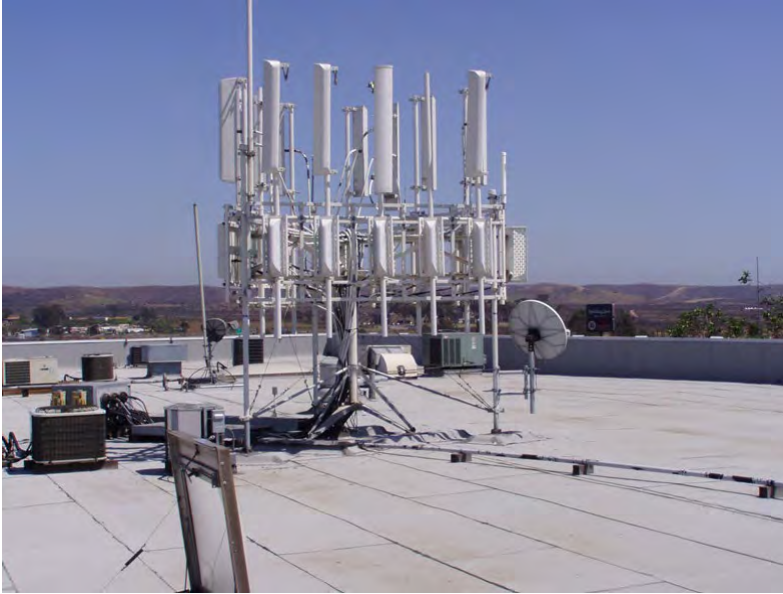
Figure A.b.3: Custom penetrating triangular frame with tripod mount

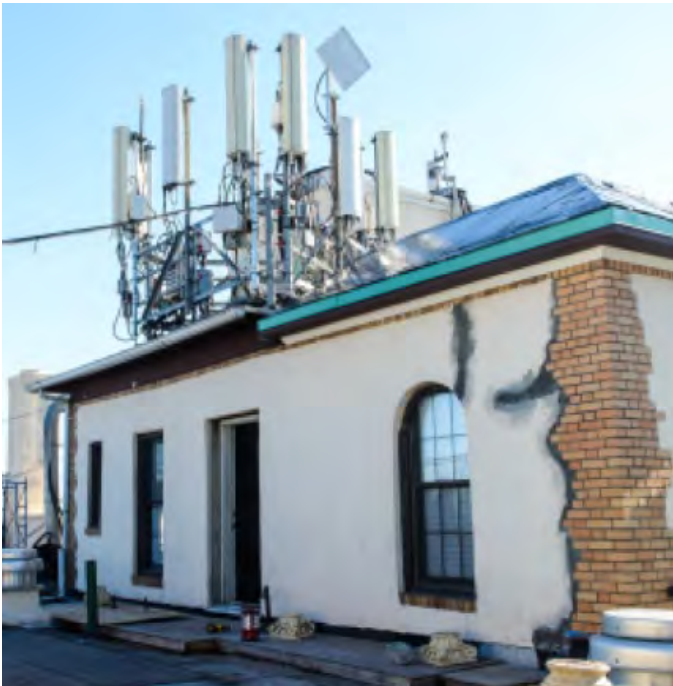
Figure A.b.4: Custom penetrating rooftop mount installed on penthouse roof

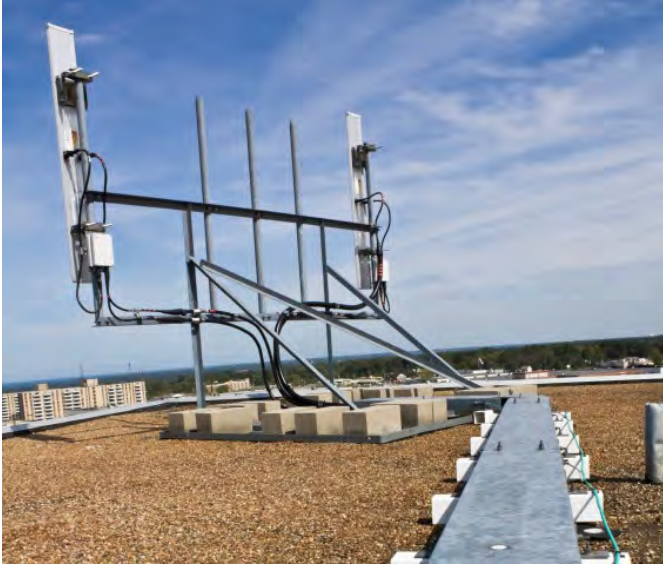
Figure A.b.5: Non-Penetrating ballasted sled mount

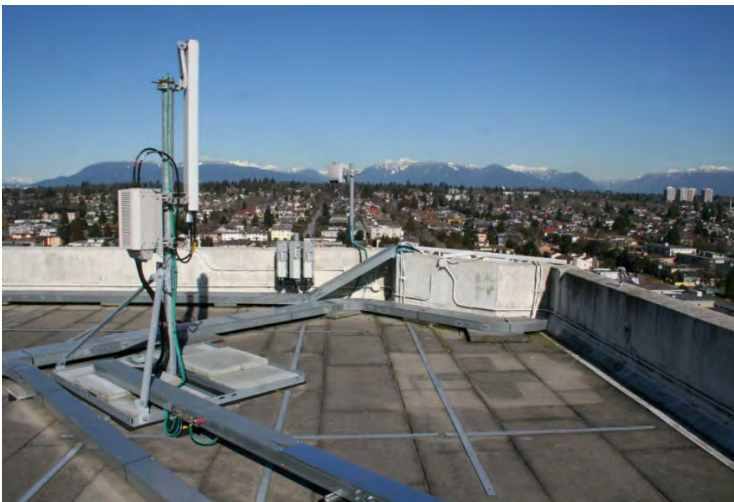
Figure A.b.6: Non-Penetrating ballasted tripod mount

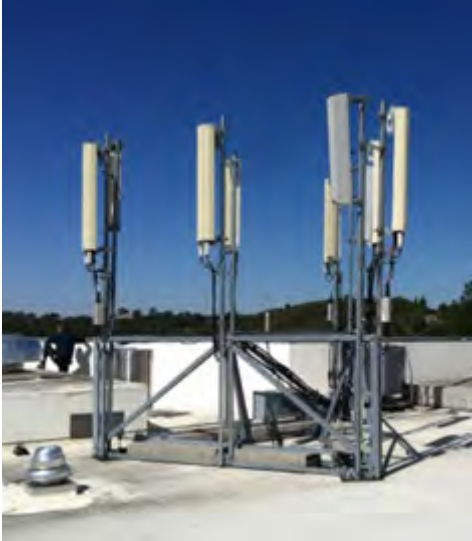
FigureA.b.7: Non-Penetrating ballasted triangular mount

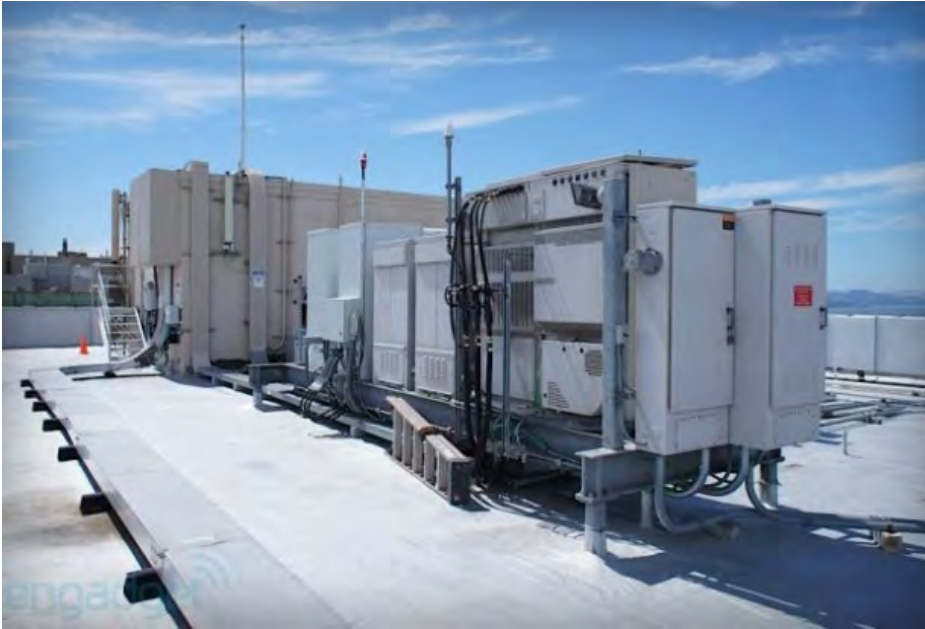
Figure A.c.1: Custom equipment platform

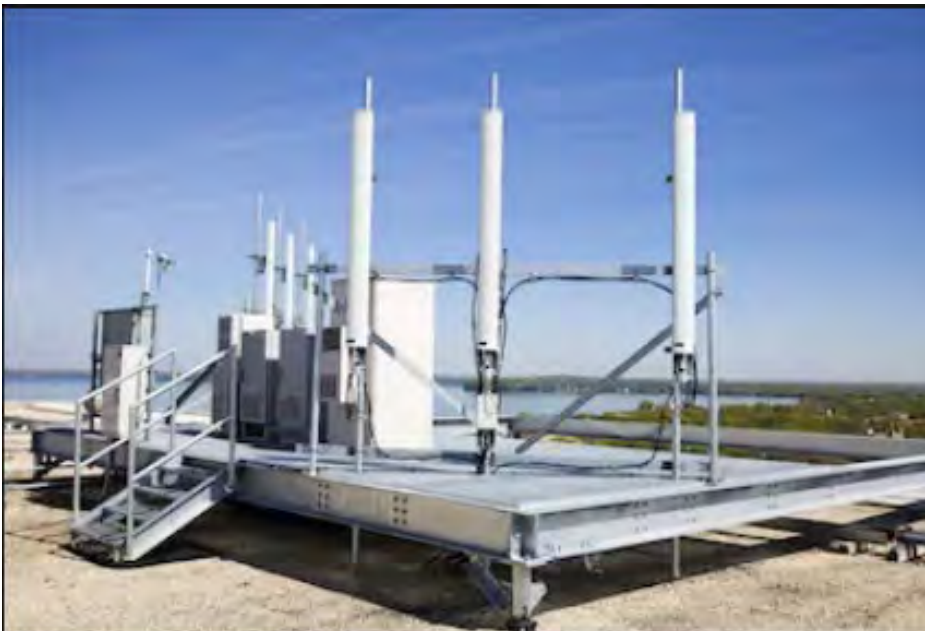
Figure A.c.2: Penetrating mount installed on equipment platform

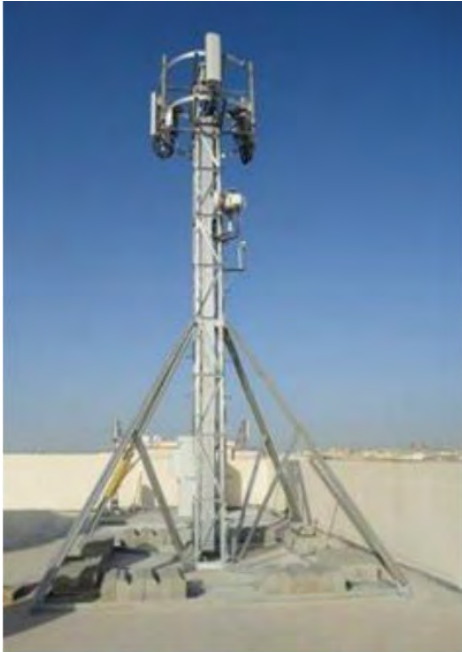
Figure A.d.1: Small Lattice Tower ballasted on corner of a building roof

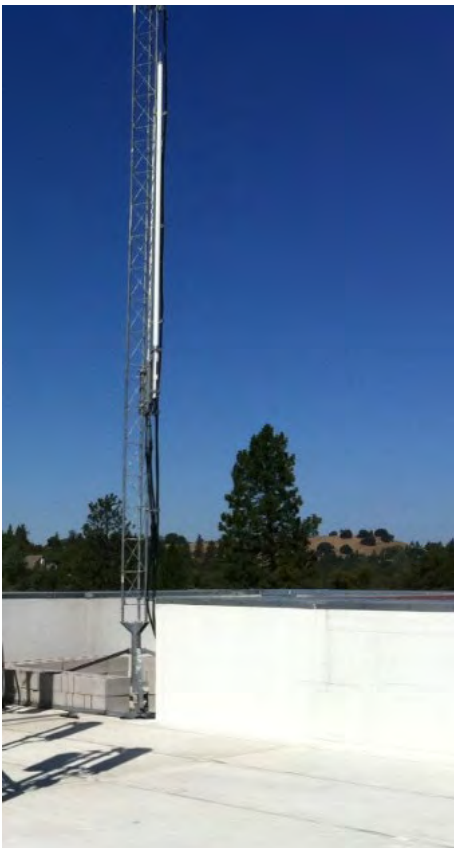
Figure A.d.2: Small Lattice Tower ballasted on corner of a building roof

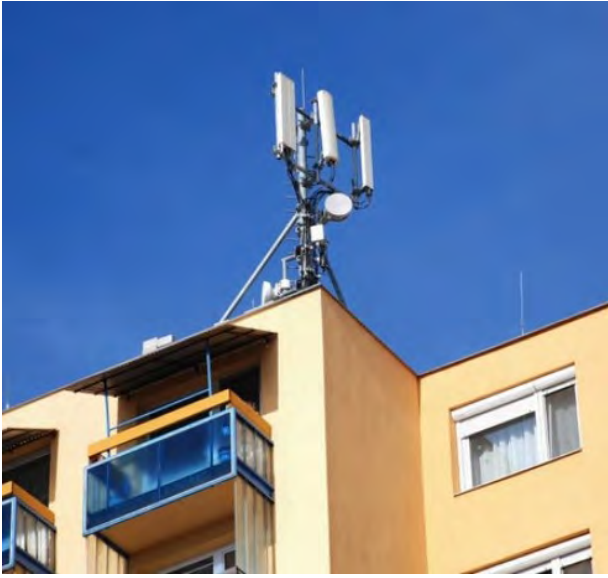
Figure A.d.3: Small Monopole Tower installed on a building roof

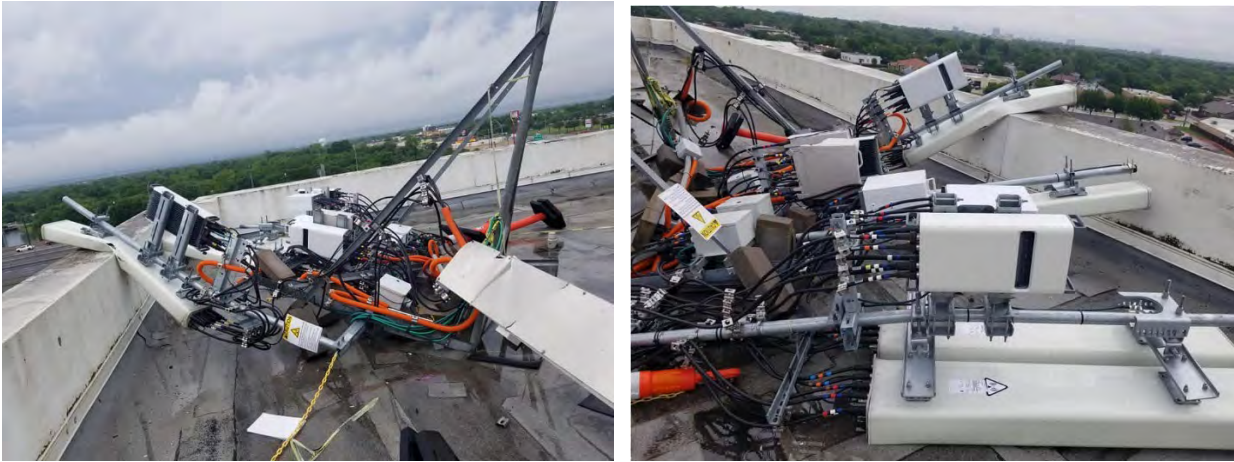
Figure B.1: Rooftop sled-mount frame overturned as a result of not having enough CMU blocks

Figure 1 and 2 in Appendix B are examples of non-penetrating mounts which failed due to overturning because they were installed using improper ballast quantities. The images show little to no ballast blocks present. Figure 3 is an example of ballast blocks improperly installed to the mount. Figure 4 reflects failure due to improper installation as the main vertical member was not fully seated in the sleeve and then secured.

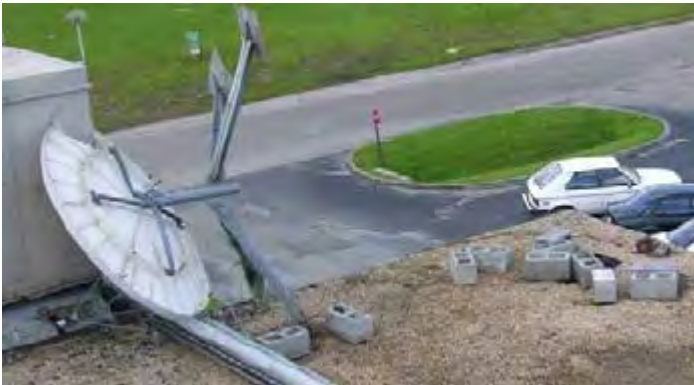
Figure B.2: Rooftop satellite Dish overturned as a result of not having enough CMU blocks and blocks not properly placed.
(Reference: FEMA 543 Risk Management Series: Design Guide for Improving Critical Facility Safety from Flooding and High Winds (January 2007))

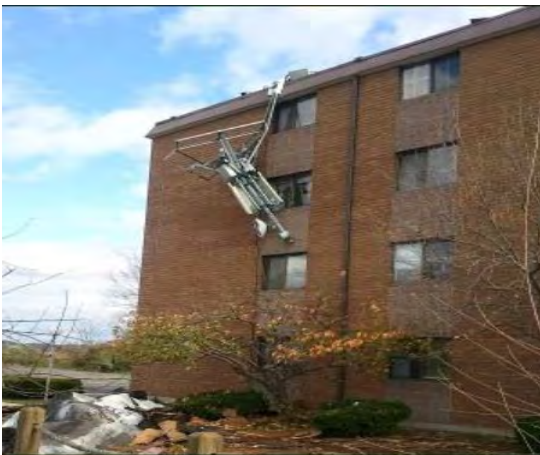
Figure B.3: Rooftop tripod mount fell off the roof as a result of not having enough CMU blocks or proper anchorage

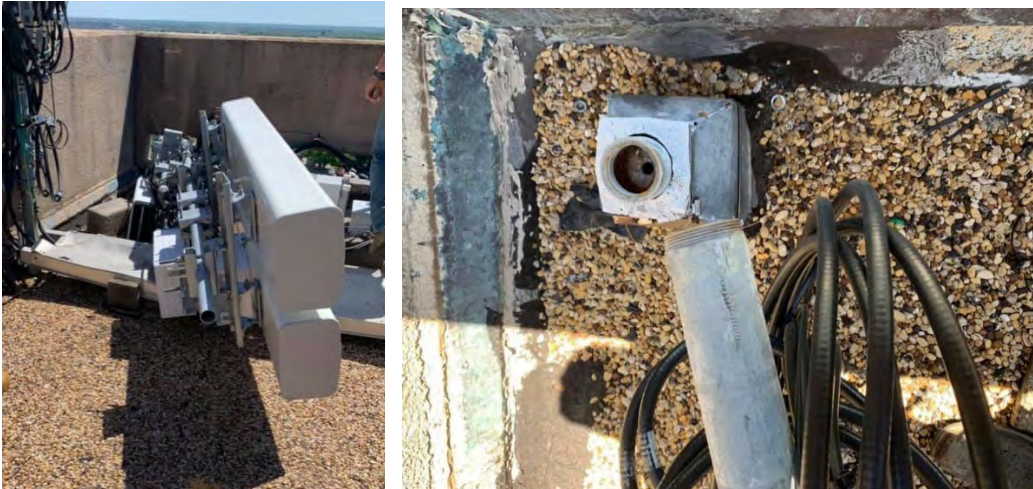
Figure B.4: Parapet Panel antenna mount failure due to improper anchorage

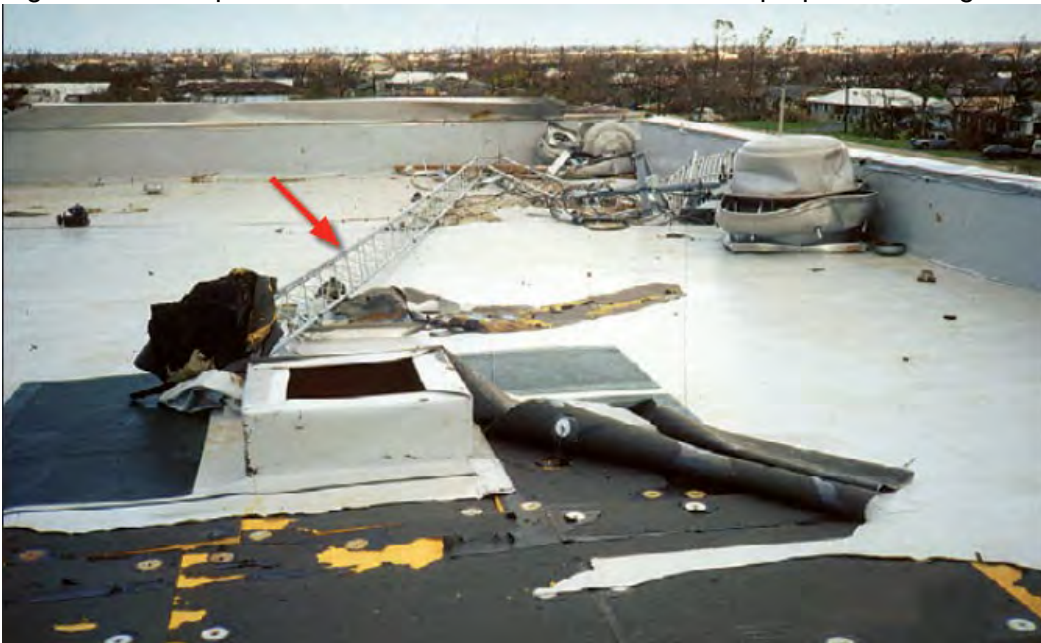
Figure B.5: Collapse of roof mounted antenna tower including progressive peeling of the roof membrane (Reference: FEMA 543 Risk Management Series: Design Guide for Improving Critical Facility Safety from Flooding and High Winds (January 2007))
